HPO - Interim Protection at Lakefront Airport and Stars & Stripes Floodwalls, Orleans.

Progress Photographs

HPO Stars and Stripes Floodwall, Orleans

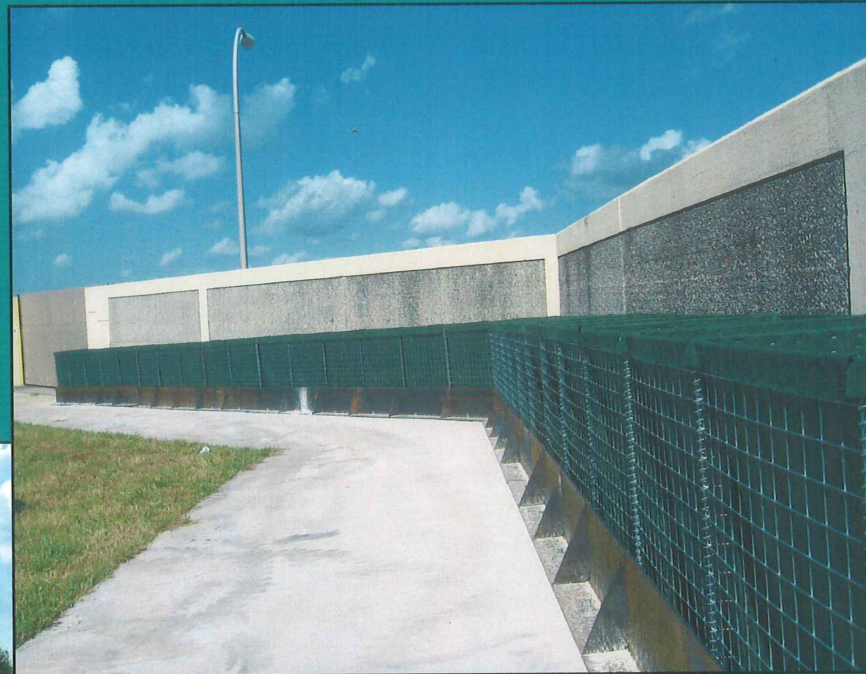
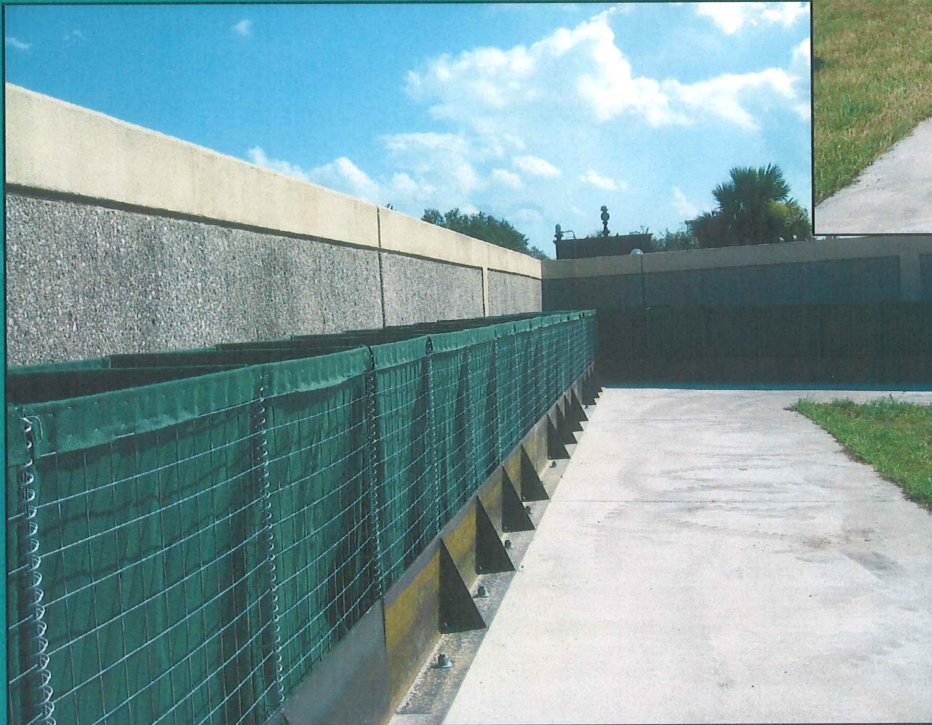
Hesco Basket (3'x3'x4') with angle support along the floodwall on the side of Leon C. Simon Road is completed.

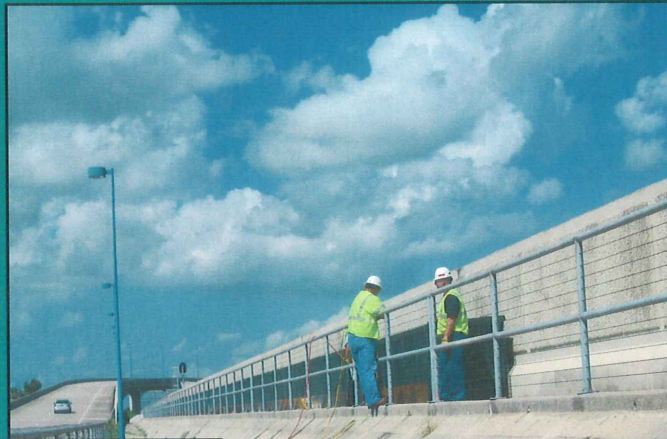
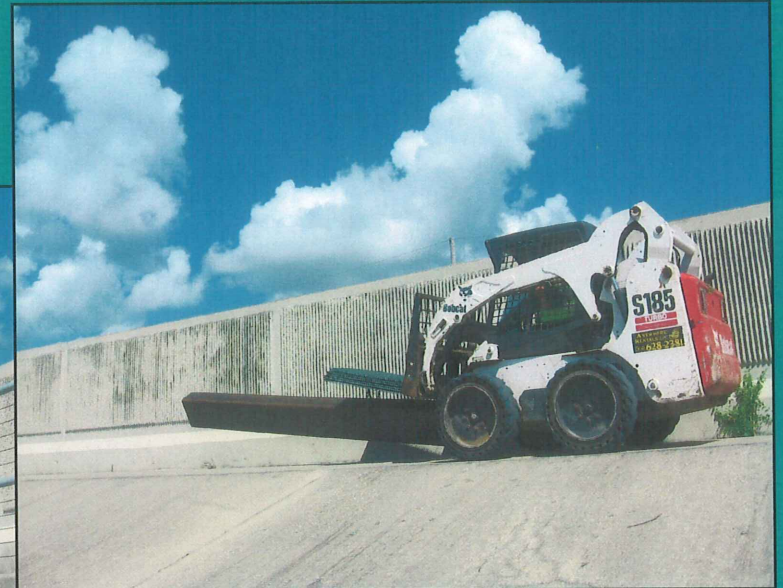
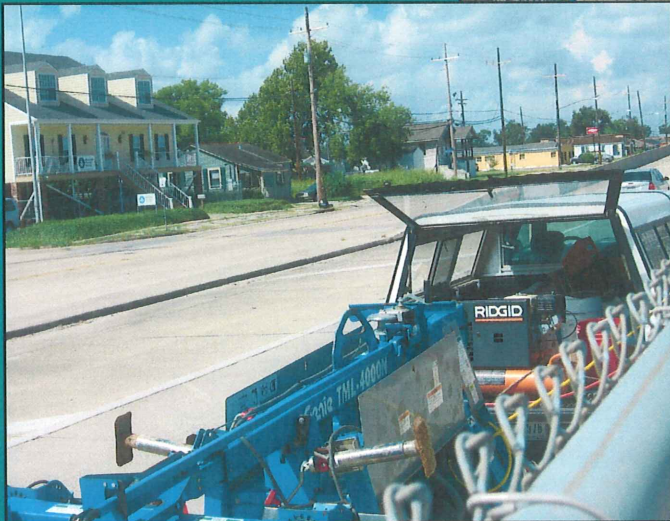
Generator, on the left, supplying power to drill the holes in the concrete and to anchor the angles with bolts. On the right, Bobcat bringing the materials to the job.

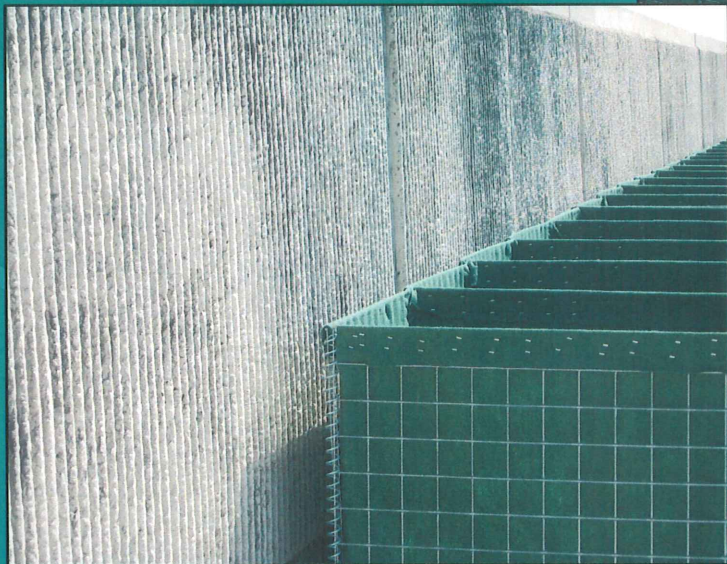
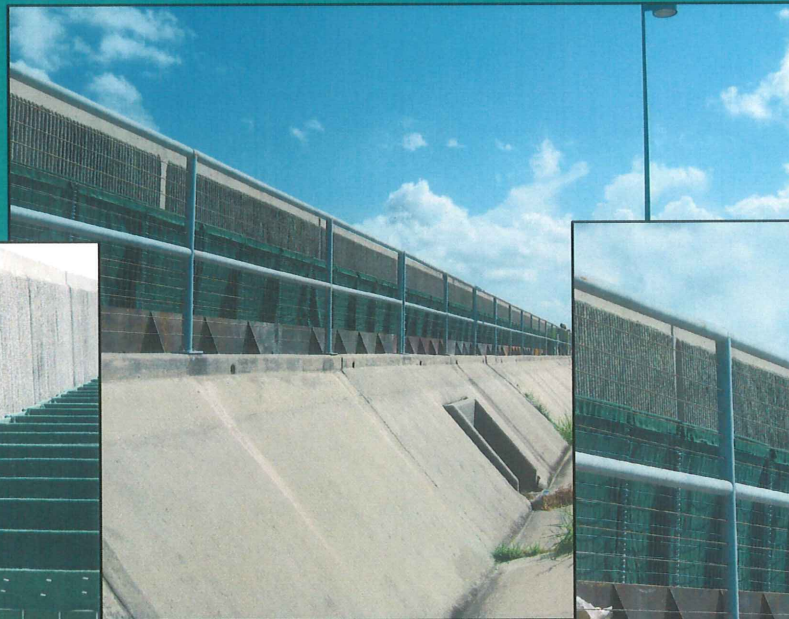
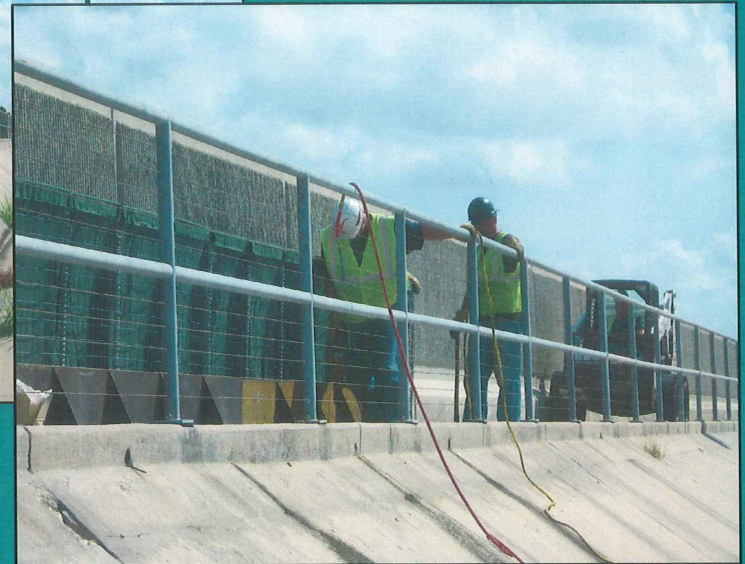
Hesco basket installation is in progress at the Hayne Blvd. along the Stars & Stripes flood wall.

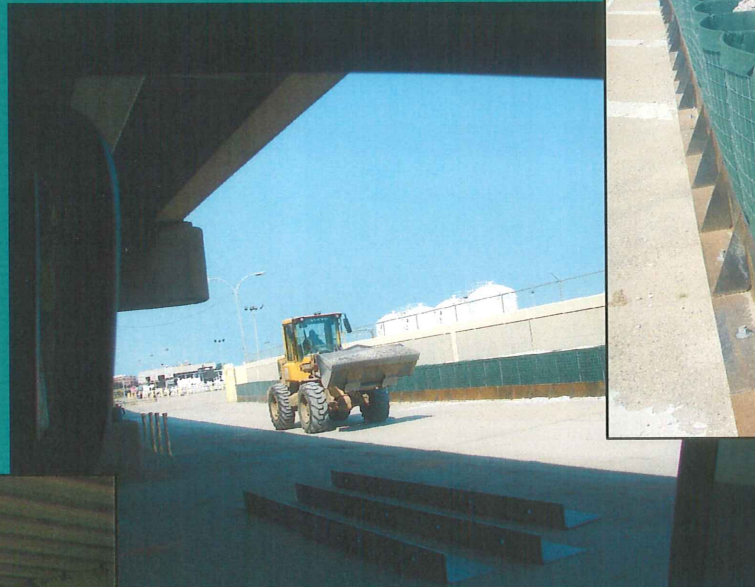
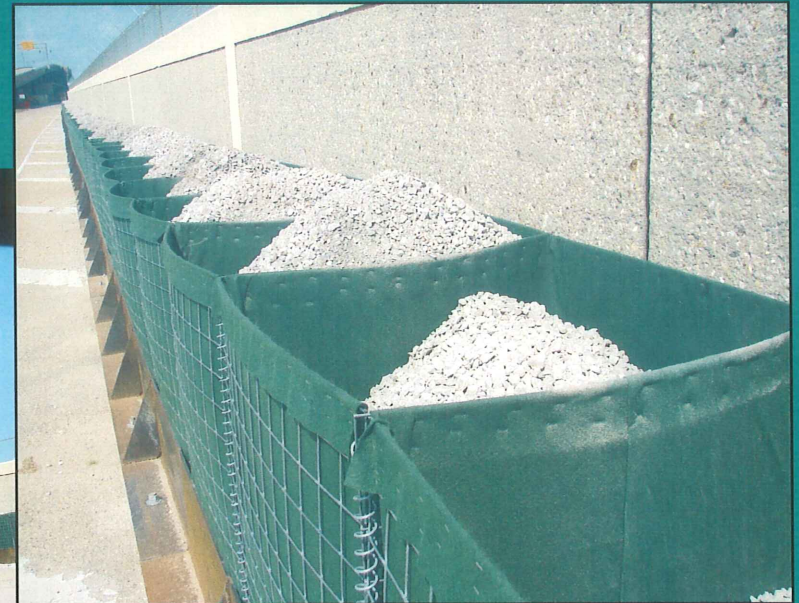
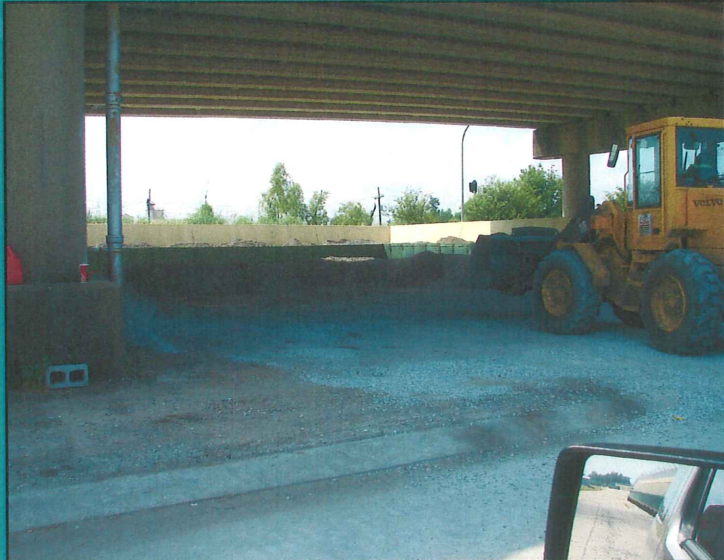
Baskets are getting filled with stones on the right. Front end loader is bringing the stones to fill the basket. Stones are stockpiled under the bridge.

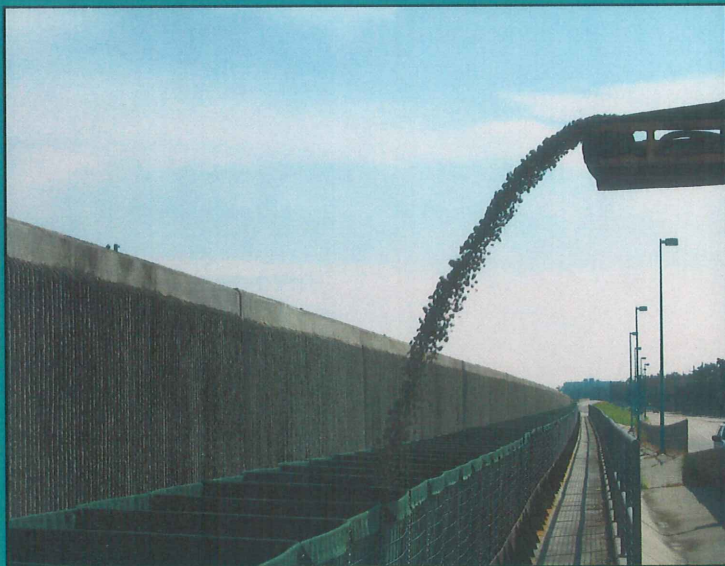
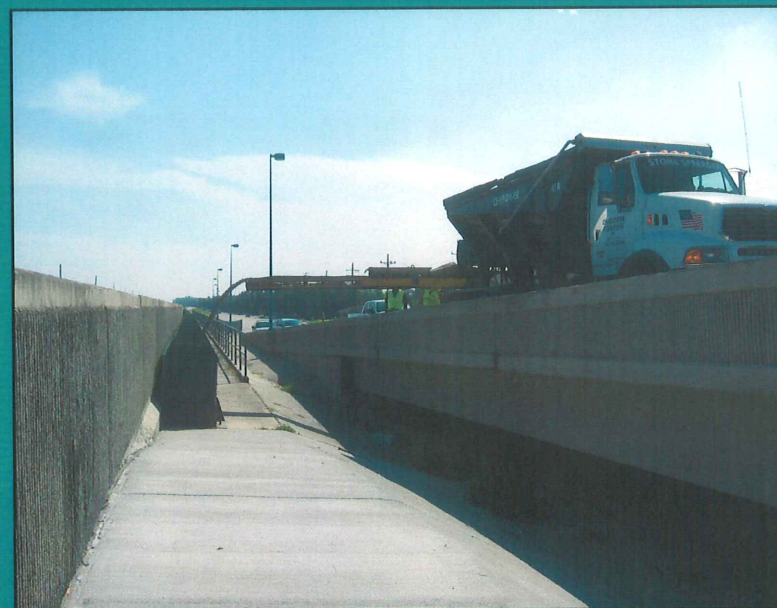
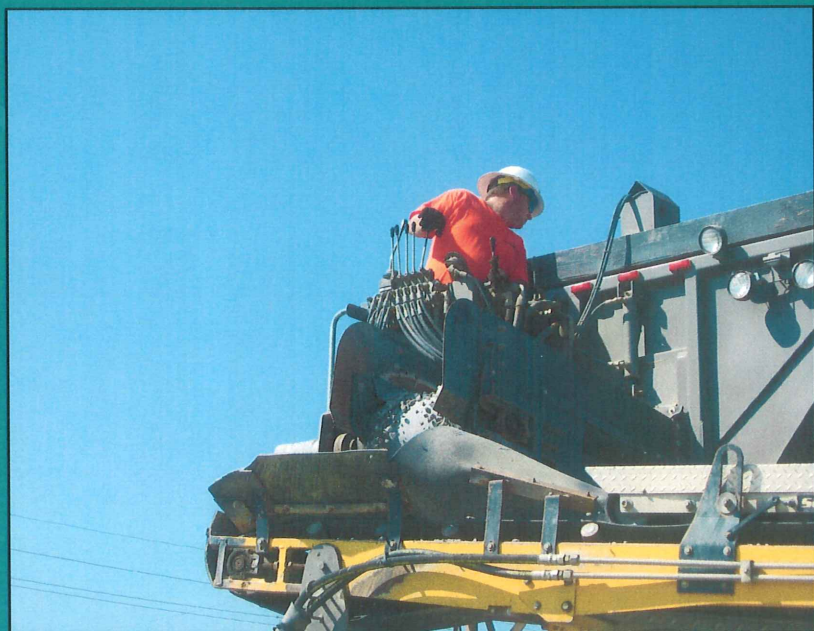
Stone filling in the basket at the Hayne Blvd. is progressing as on August 27, 2007. The stone material is pumped, vibrated, and placed in the baskets through the conveyor.

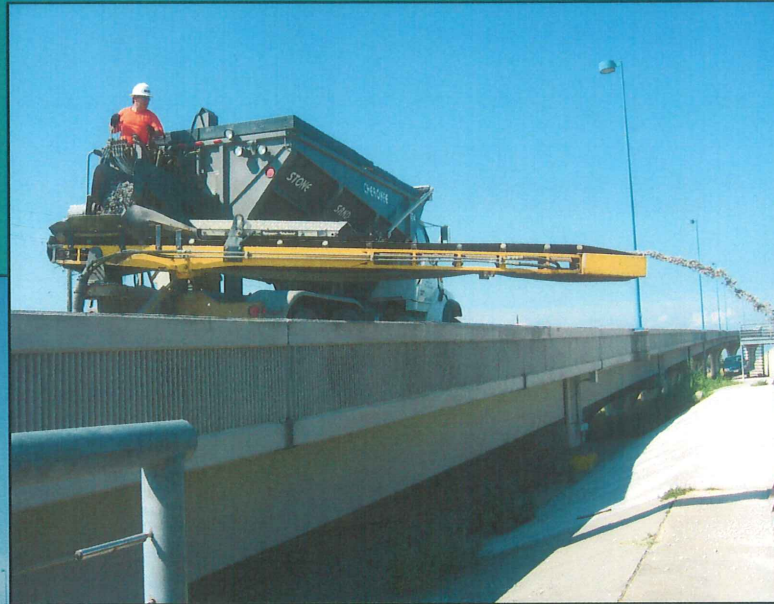
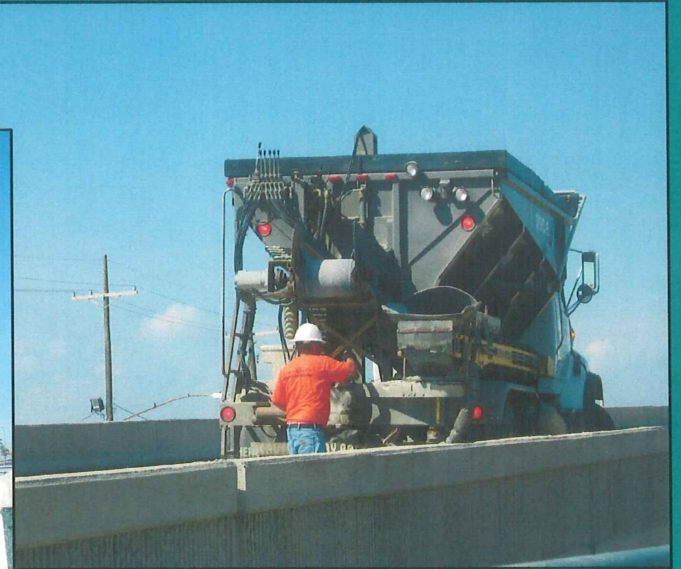
The stone spreader is ready for refill.

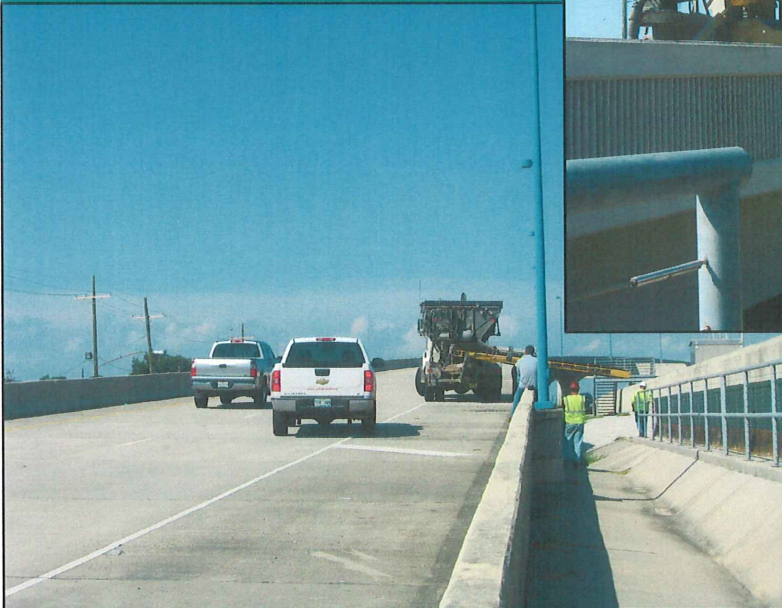
One lane is open for traffic when the work is in progress.

The stone spreader is on the bridge ramp and conveyor is extended up to the baskets due to the limited working space at the baskets. Six baskets are filled one time (+/- 15 tons of stone).

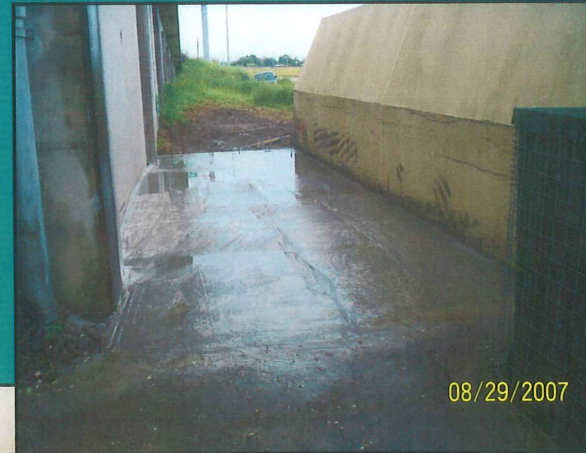
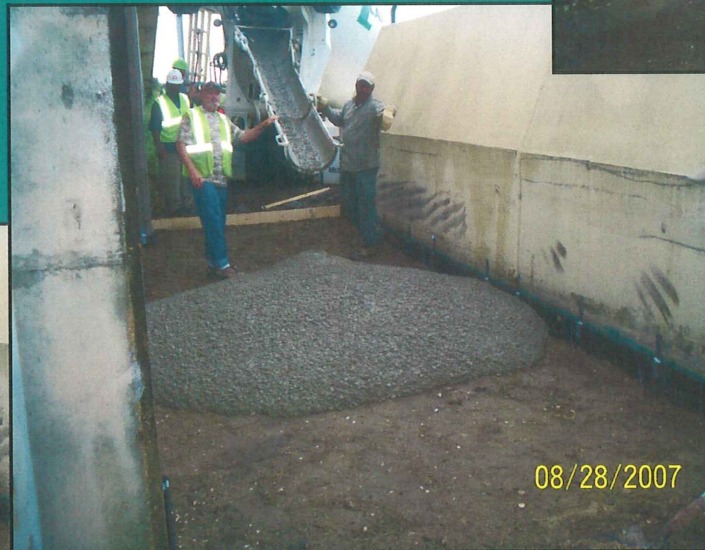
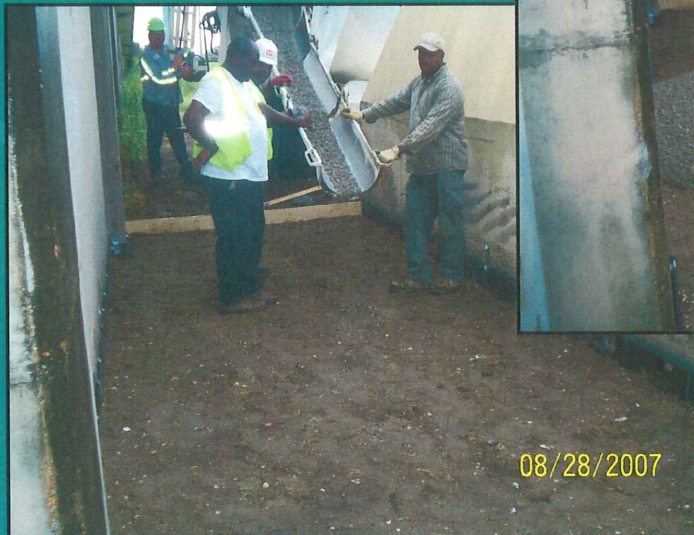
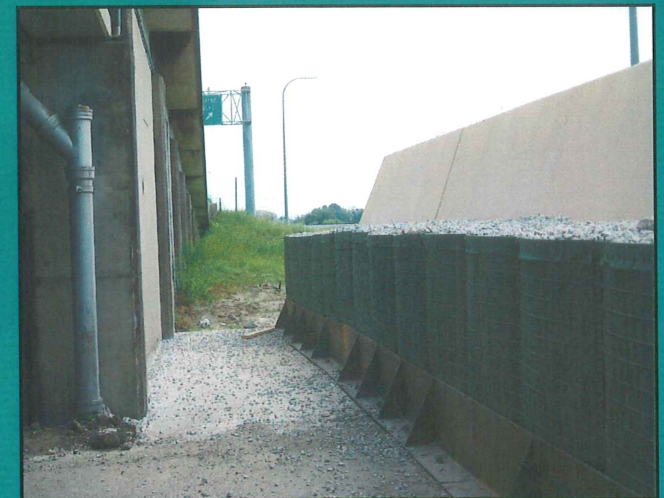
Interim concrete scour slab (9'x26') is extended between the Seabrook Bridge and I-Wall to provide an anchoring surface for the hesco baskets.

Stone filled hesco baskets are anchored to the newly poured slab

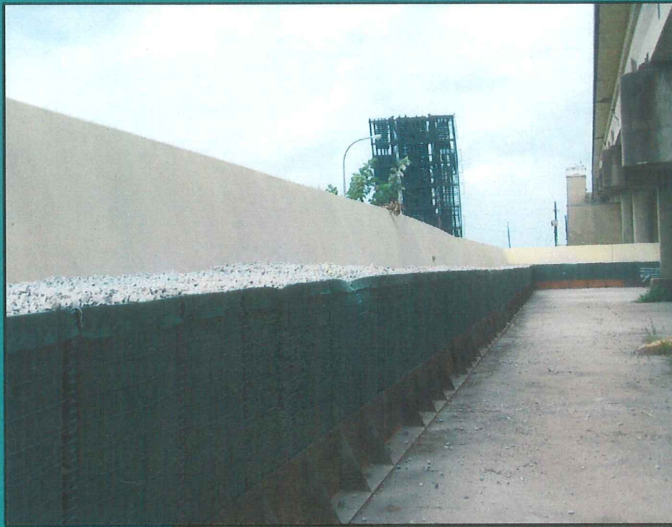
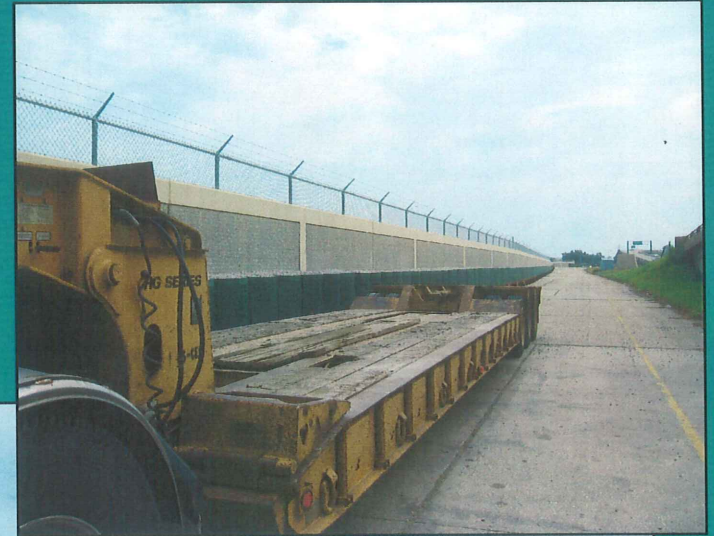
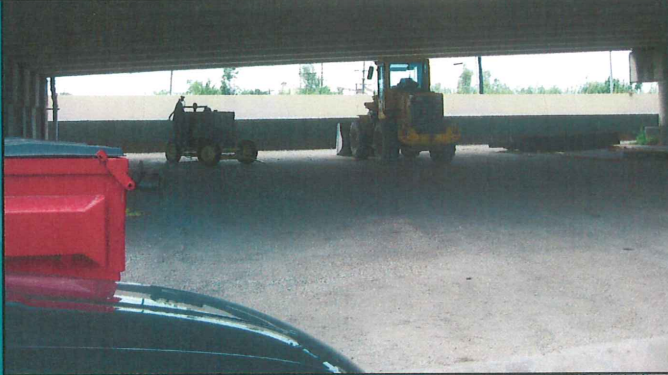
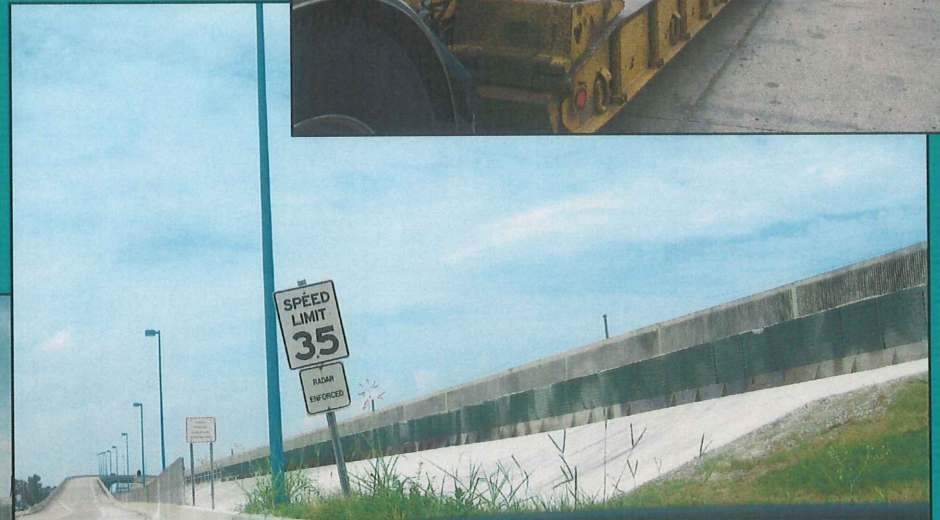
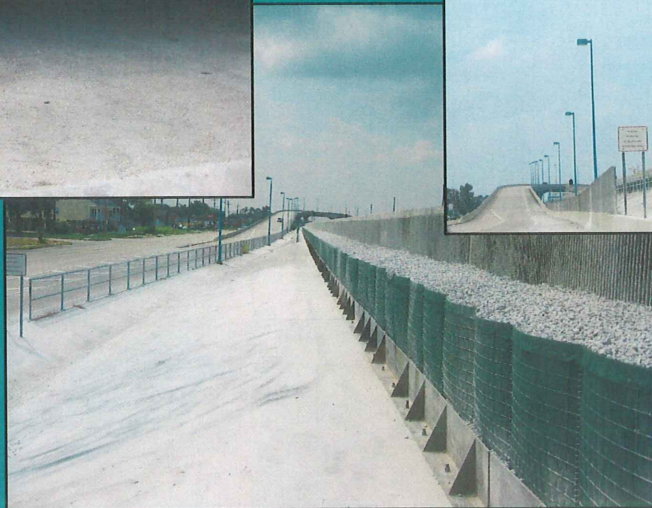
Project is substantially
completed on
September 5, 2007

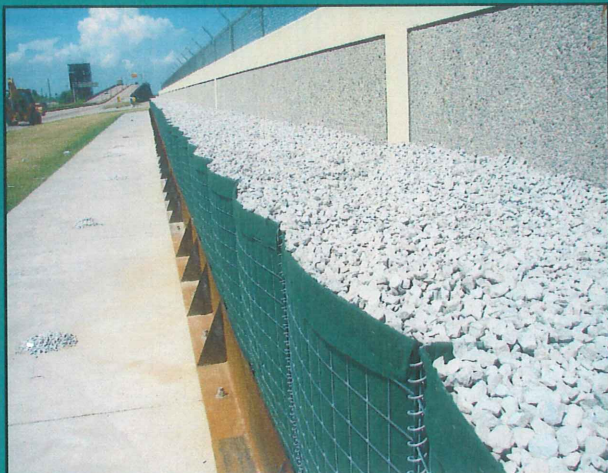
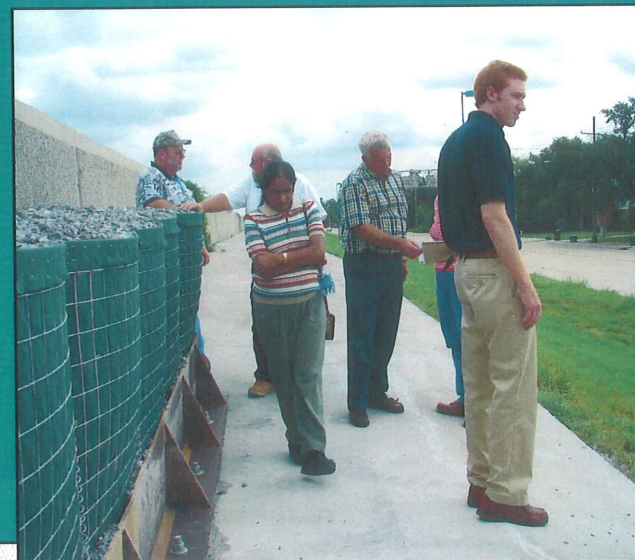
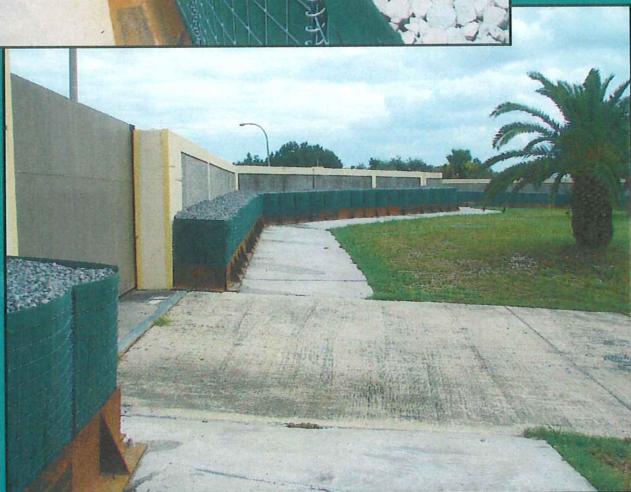
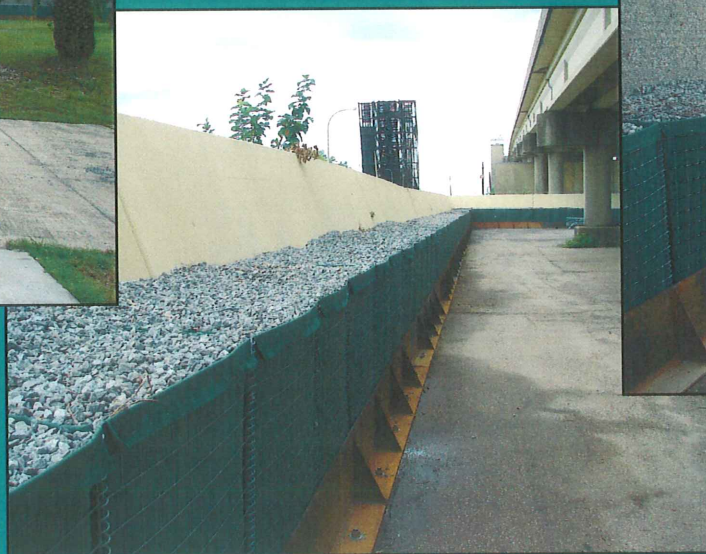
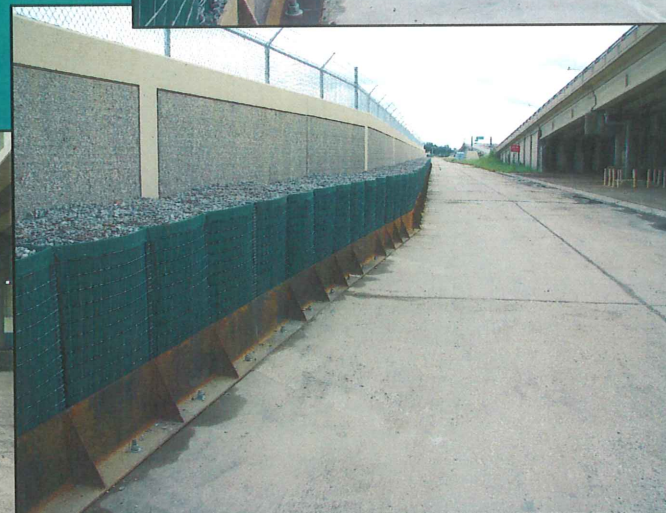
Final inspection performed
on September 12, 2007.
